ZAVOD ZA
GRADBENIŠTVO
SLOVENIJE

REPORT

No. P099/14-440-2

On the testing of anticorrosion protection coating "MCU-Miozinc 140 μm + MCU-Topcoat 80 μm " according to a standard EN ISO 12944-6:1998 for C5-I/H and C5-M/H

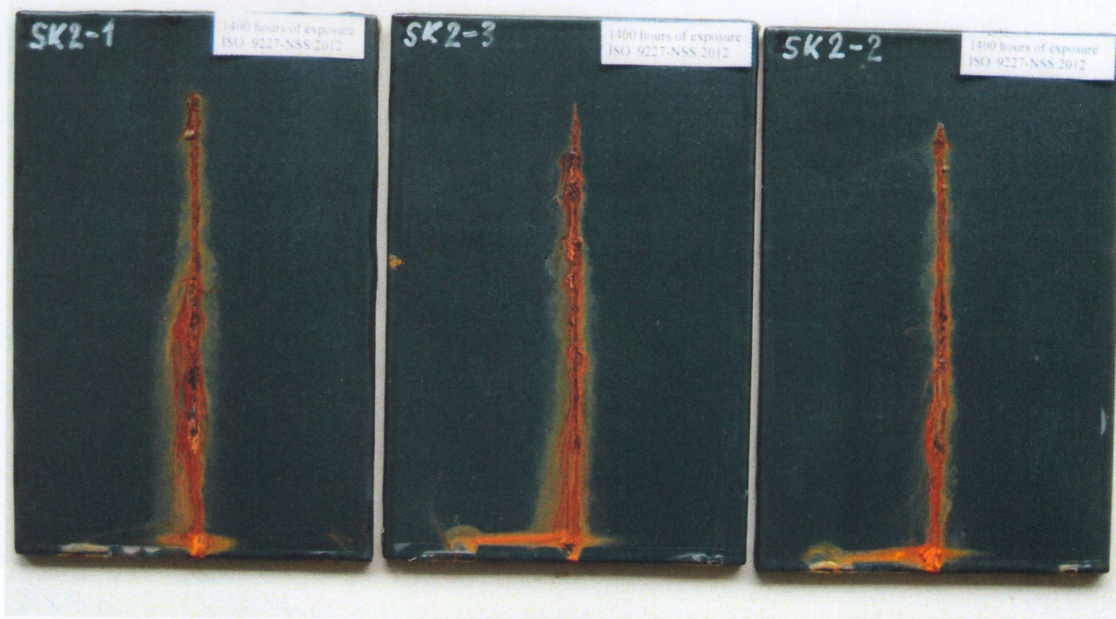
Figure No. 1 (27941d-15)

Tests	Panel			Requirements
	R2-1	R2-2	R2-3	
Measured DFT [μm]	215 \pm 17	238 \pm 16	229 \pm 26	
Assesment before test:				
- ISO 2409:13 (class):	0	0	-	0
- ISO 4624:02 [MPa]		7,2 \pm 1,3* ¹	6,7 \pm 1,3* ¹	>5Mpa or no adh. break to substrate
Test 1: Neutral Salt Spray - ISO 9227:2012				
Scratch: Tool Sikens, 0,5 mm	SK2-1	SK2-2	SK2-3	
Exposure time: 1440 h				
Measured DFT [μm]	221 \pm 16	219 \pm 8	215 \pm 24	
Assessment after finished exposure: (Picture No.1 – Annex 3)				
ISO 4628-2:03 (blistering)	0(S0)	0(S0)	0(S0)	0(S0)
ISO 4628-3:03 (rusting)	Ri 0	Ri 0	Ri 0	Ri 0
ISO 4628-4:03 (cracking)	0	0	0	0
ISO 4628-5:03 (flaking)	0	0	0	0
ISO 4628-8:05 (corr. around a scribe)	< 0,3 mm	<0,3 mm	<0,3 mm	< 1 mm
ISO 2409:13-1a/A.1 (class):	0	-	-	0 or 1
ISO 4624:02 [MPa]	-	5,7 \pm 0,7* ¹	5,2 \pm 0,6* ¹	>5Mpa or no adh. break to substrate

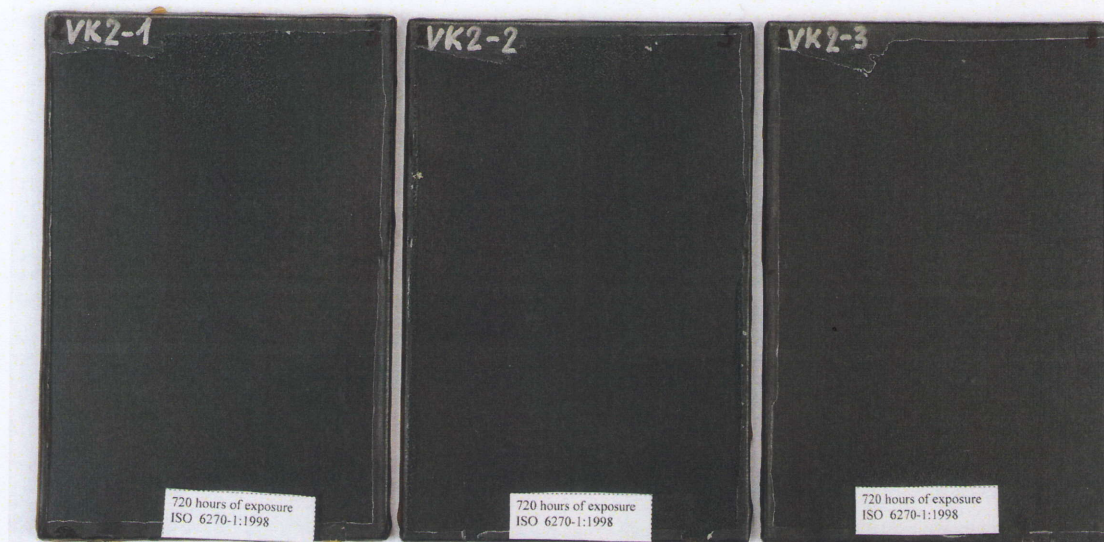
Figure No. 2 (27822d-07)

Test 2: Continuous condensation - ISO 6270-1:1998 Exposure time: 720 h	Panel			Requirements
	VK2-1	VK2-2	VK2-3	
Measured DFT [μm]	228 \pm 18	212 \pm 22	223 \pm 20	
Assessment after testing: (Picture No.2 – Annex 3)				
ISO 4628-2:03 (blistering)	0(S0)	0(S0)	0(S0)	0(S0)
ISO 4628-3:03 (rusting)	Ri 0	Ri 0	Ri 0	Ri 0
ISO 4628-4:03 (cracking)	0	0	0	0
ISO 4628-5:03 (flaking)	0	0	0	0
ISO 2409:13-1a/A.1 (class):	0	-	-	0 or 1
ISO 4624:02 [MPa]	-	6,8 \pm 1,1* ¹	7,0 \pm 1,2* ¹	>5Mpa or no adh. break to substrate

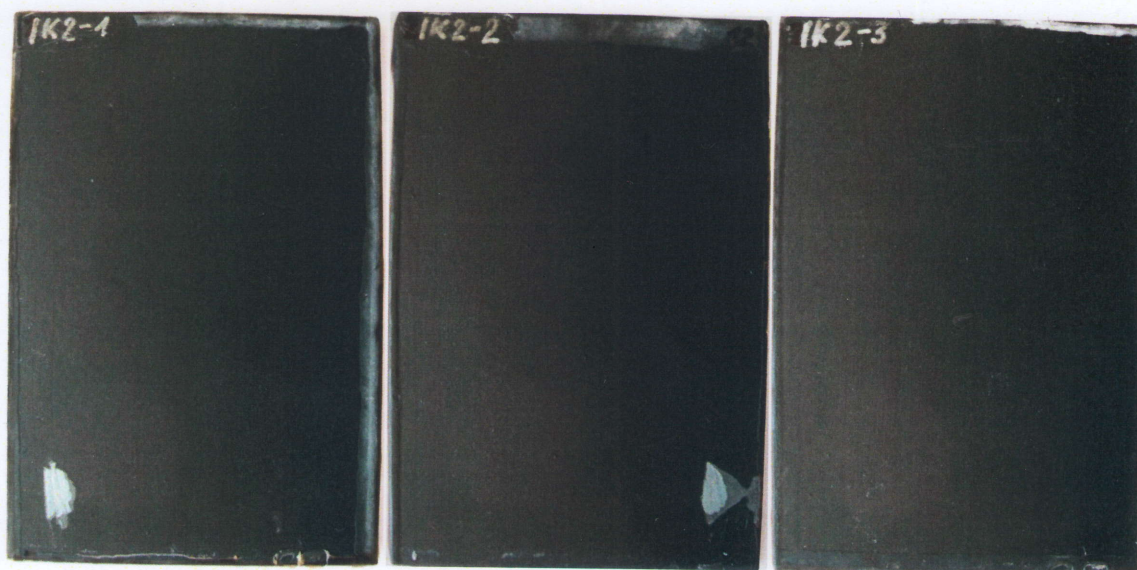
Figure No. 3 (27880d-18)

Test 3: SO ₂ test with condensation of moisture - ISO 6270-1:1998 ISO 6988:1985 Exposure time: 30 cycles	Panel			Requirements
	IK2-1	IK2-2	IK2-3	
Measured DFT [μm]	221 \pm 14	216 \pm 20	211 \pm 8	
Assessment after testing: (Picture No.3 – Annex 3)				
ISO 4628-2:03 (blistering)	0(S0)	0 (S0)	0(S0)	0(S0)
ISO 4628-3:03 (rusting)	Ri 0	Ri 0	Ri 0	Ri 0
ISO 4628-4:03 (cracking)	0	0	0	0
ISO 4628-5:03 (flaking)	0	0	0	0
ISO 2409:13 (class):	0	-	-	0 or 1
ISO 4624:02 [MPa]	-	7,2 \pm 0,9* ¹	7,5 \pm 1,1* ¹	>5 Mpa*or no adh. break to substrate
